The Main Defects and Deformations of the Roadbed and Urgent Measures to Eliminate Them

Tashkent State Transport University (Tashkent, Republic of Uzbekistan)

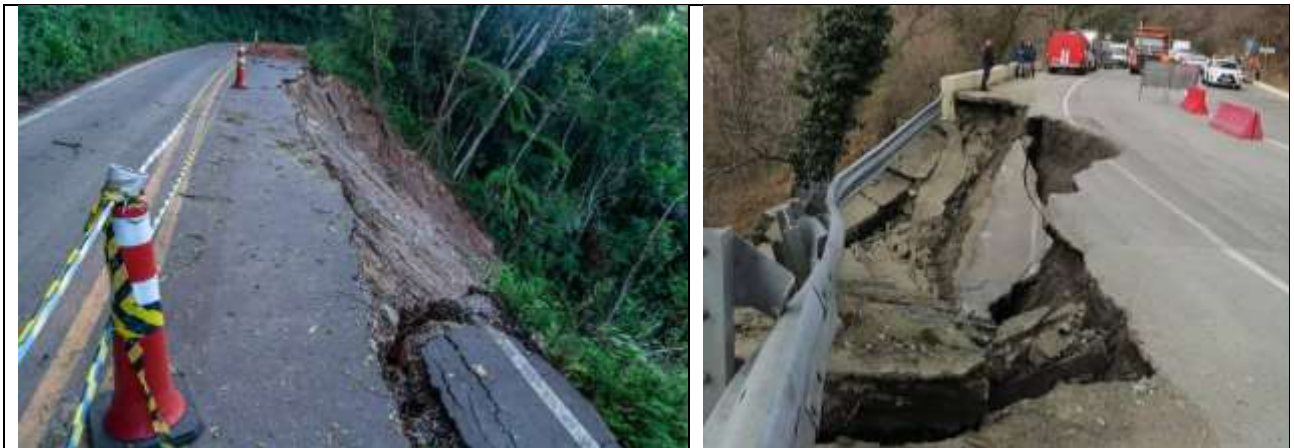
Figure 2. Landslides of the slopes of the embankment of the road.

2. Slide of embankment slopes - delamination of the slope part of the embankment with the capture of the main platform most often to the axis of the road and its displacement to the bottom of the slope, sometimes with the capture of the embankment base.

Identification signs: the appearance of longitudinal cracks on the roadsides, slopes of the asphalt concrete pavement, bumps on the slope and moistened folds in the lower part of the slope; distortion of the outlines of the slopes and the ground surface near the base of the slope. In the case of a slide, at first there is a vertical displacement of the soil with the formation of a separation wall, then the displacement of the soil to the left side. As a rule, the other part of the embankment remains stable. This distinguishes the slope slide from the general displacement of the entire embankment.

Causes: insufficient density of embankment soils and slope parts; overestimated steepness of slopes; construction of an embankment of weak soils that are not suitable for construction; difference in density and moisture content of the core and slope soils; the presence of longitudinal beds, the presence of an overestimated steepness of its slope and the wetting of the contact of clayey and draining soils; the presence of weak soils at the base of the slope part of the embankment; poor current maintenance of the roadbed; waterlogging of the soil by abundant precipitation, melt water.

Urgent measures: leveling of roadsides, sealing cracks, snow removal at the end of winter; preventing water from entering the embankment body (waterproofing) or interception of water and from its waters beyond the embankment); cutting of creeping soils, slopes; cutting benches on a clay core and restoration with high-quality soil with standardized compaction; sprinkling berms or counter-banquets to strengthen the slope. When restoring the embankment with draining soils, it is unacceptable to overload the upper part of the slope, and it is necessary to protect from the contact of clayey and draining soils from the water of absorbing water.
