# Analysis of Malfunctions in the Wheel-Motor Unit of Locomotives

This article examines the analysis of the malfunction of the wheel-motor unit of diesel locomotives of the UzTE116M series. The main causes of failures of the wheel-motor units are considered; statistical data on the causes of malfunctions of locomotive units after major repairs, as well as the causes of damage to the ED-118B(A) electric traction motors, taking into account real operating conditions.

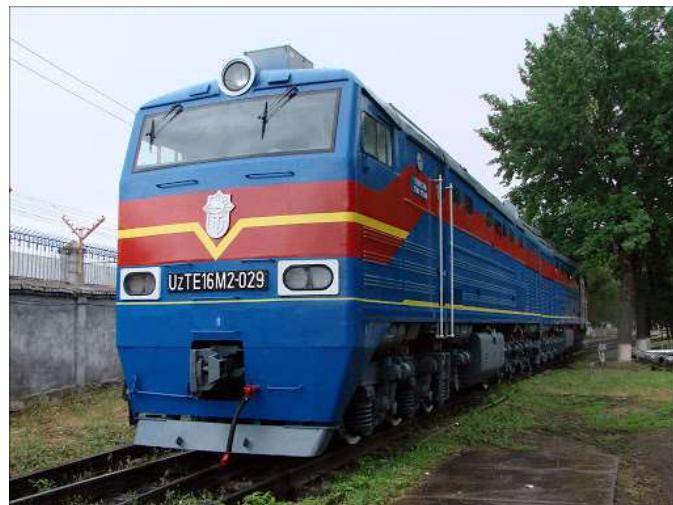
**Figure 1.1. – External view of the UzTE16M diesel locomotive.**

The block of the UzTE16M diesel locomotive (Figure 1.1) is made with a support-axial suspension of the traction electric motor ED118B(A) and a one-way gear drive. From gear wheels, power is

Figure 1.1 shows a photo of the UzTE16M mainline diesel locomotive.
